DEVELOPMENT OF OPTIMUM TIG WELDING PROCEDURE FOR
PRODUCTION OF WELDMENTS IN 12% NI MARAGING STEEL.

Prepared for
National Aeronautics and Space Administration

July 1971

GENERAL DYNAMICS
Electric Boat Division
Groton, Connecticut

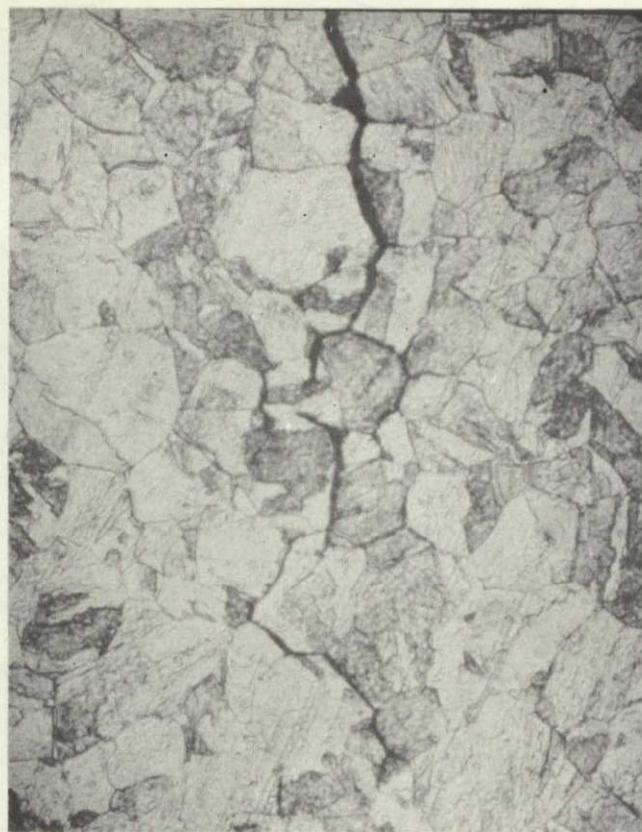
VIEW AT $\frac{1}{2}$ CRACK DEPTH SHOWING
OXIDATION ON CRACK SURFACE.

CRACK TIP AREA ETCHED TO ILLUSTRATE
INTERGRANULAR CRACKING

FIGURE 81
SECTIONS THROUGH BASE METAL CRACK FOUND IN VESSEL "E"

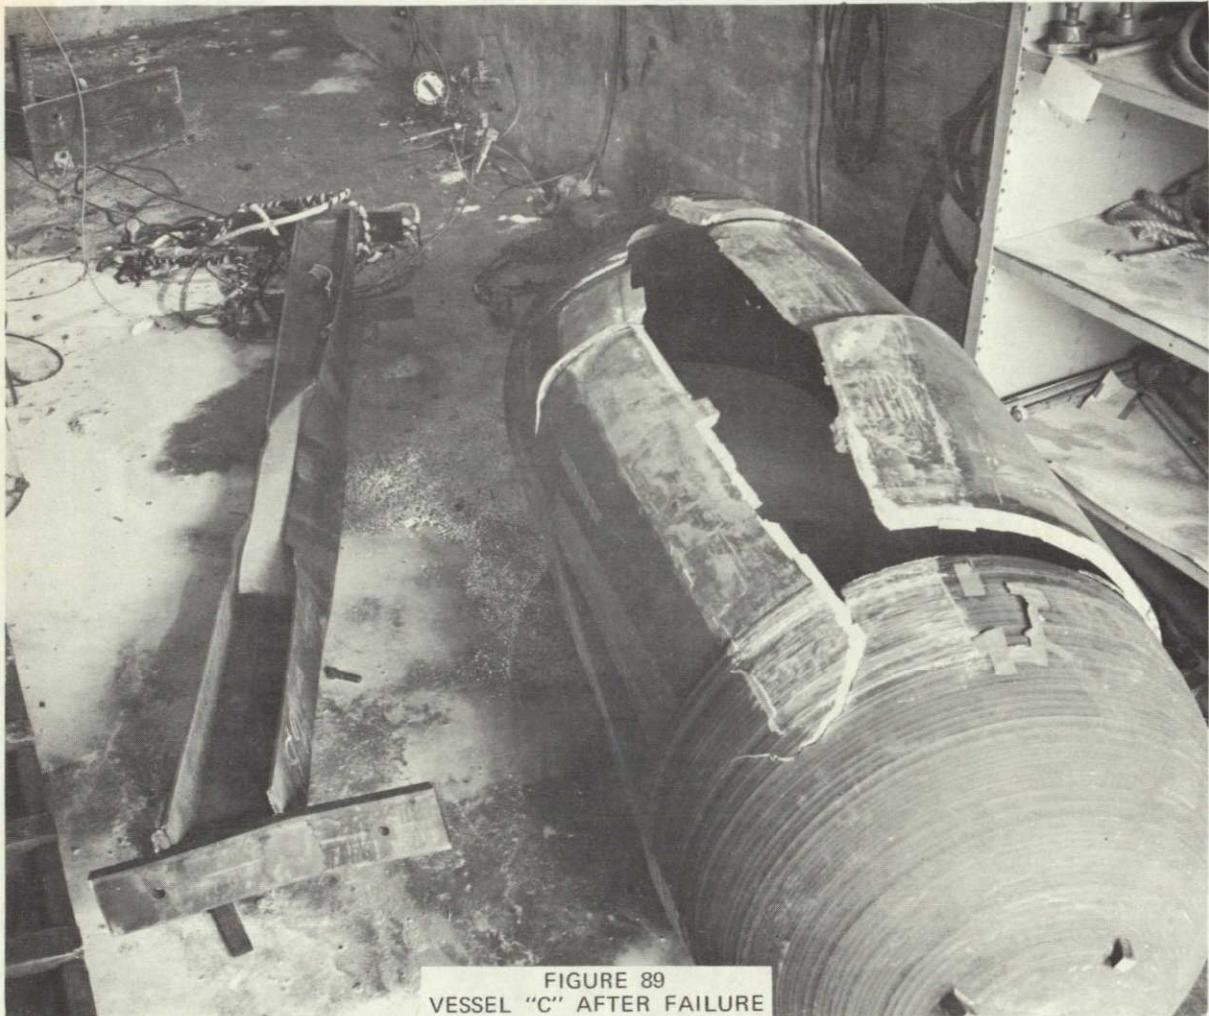
FIGURE 89
VESSEL "C" AFTER FAILURE
